**MARYLAND HISTORICAL TRUST
DETERMINATION OF ELIGIBILITY FORM**

Property Name: Carpenters Square (May Turpin Farm) Inventory Number: QA-131

QA-131
May Turpin Farm
Wye Mills vicinity
Private

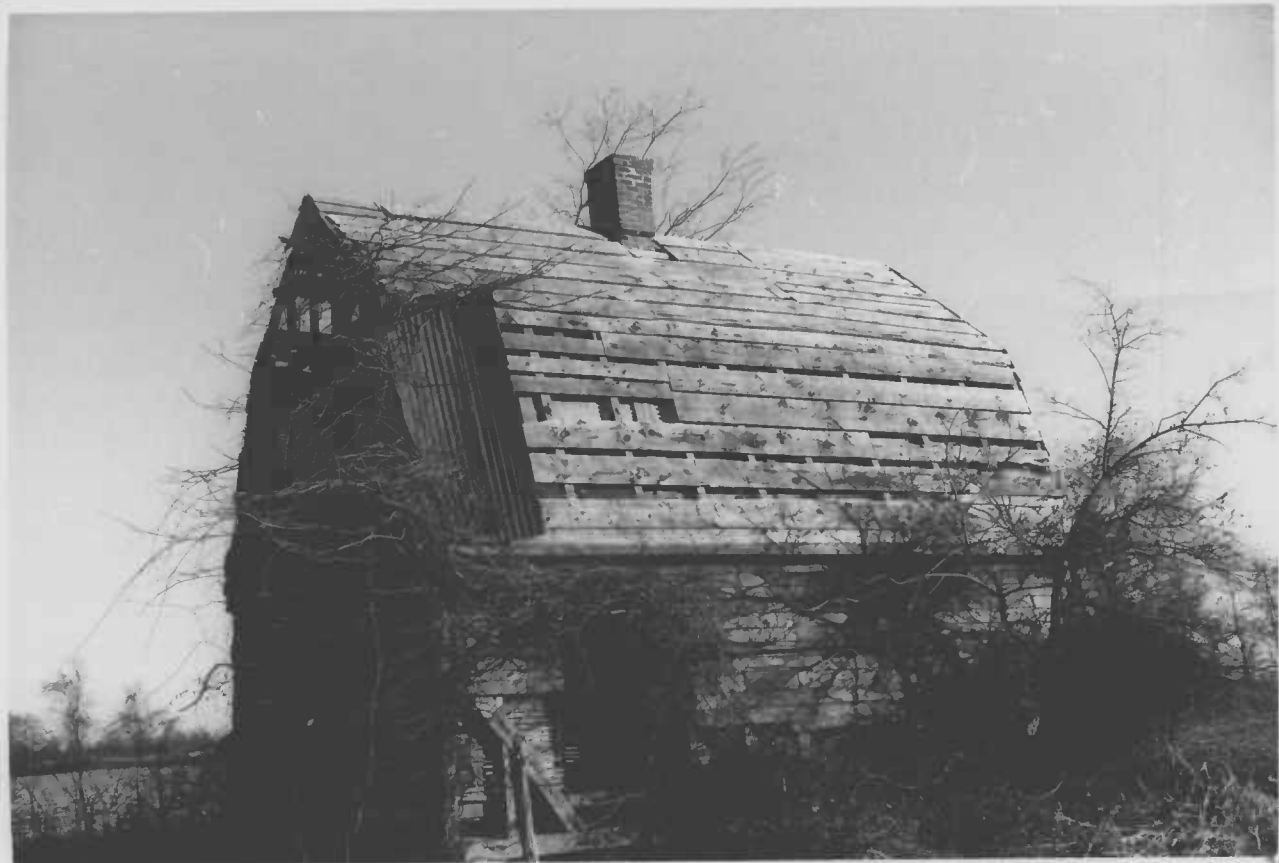
QA-131 May Turpin Farm

Building to rear of house
(since destroyed)

Queen Anne's County Historical
Society file photograph
